# UNDERWATER BRIDGE INSPECTION REPORT

STRUCTURE NO. 7150

BLUE EARTH RIVER

MINNESOTA DEPARTMENT OF TRANSPORTATION  
UNDERWATER BRIDGE INSPECTION

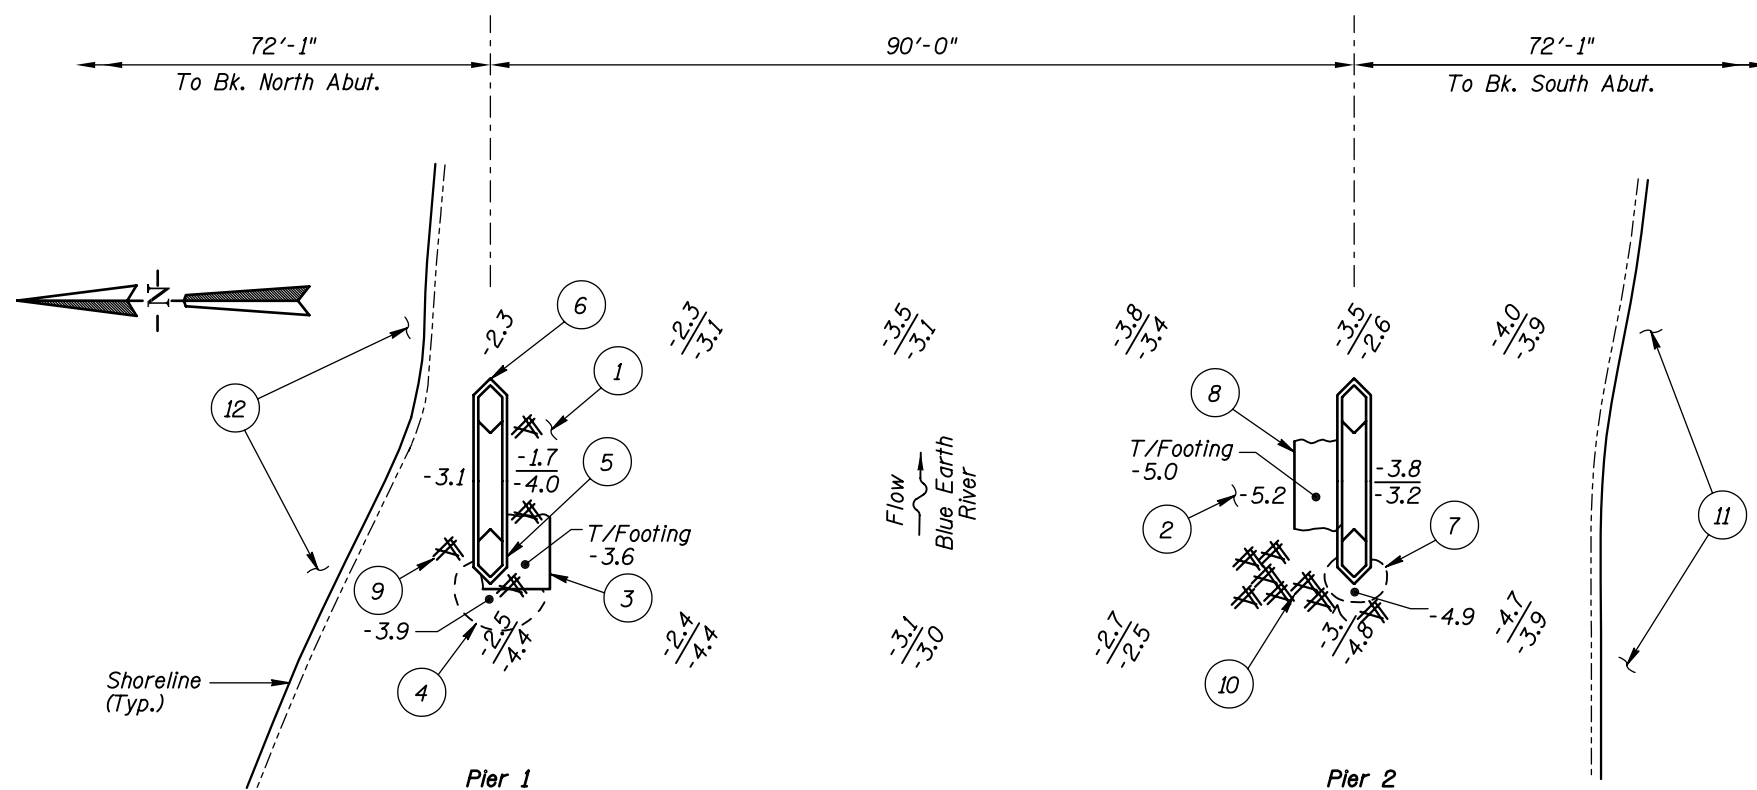
**SOUNDING PLAN**

- The channel bottom consisted of gravel overlaid with fine silty sand with 2 inches of probe rod penetration.
- Then channel bottom consisted of fine silty sand with 2 inches of probe rod penetration.

- The top of the footing was exposed from the upstream nose to the upstream quarter point along the south face of Pier 1 with 3 inches of vertical face exposure detected.

- A scour depression, 2 feet in radius and 1.5 feet deep, was observed at the upstream nose of Pier 1.
- An area of section loss, 1.5 feet wide by 6 inches high with a penetration of 1/8 inch, was observed 1.5 feet below the waterline on the south face of the upstream end of Pier 1.

- An area of section loss, 10 inches wide by 1.5 feet high with a penetration of 1 inch, was observed at the waterline on the downstream nose of Pier 1.

- A scour depression, 5 feet in radius and 1.5 feet deep, was observed at the upstream nose of Pier 2.
- The footing was exposed along the north face of Pier 2 with 2 inches of vertical face exposure detected.

- A light accumulation of 6-inch-diameter timber debris was scattered on the channel bottom around Pier 1.
- A moderate accumulation of timber debris, up to 1 foot in diameter, was observed at the upstream end of Pier 2 and extending along the north face.

- The South Abutment was well protected with heavy riprap and large pieces of concrete.
- The north embankment exhibited heavy erosion due to poor slope protection.

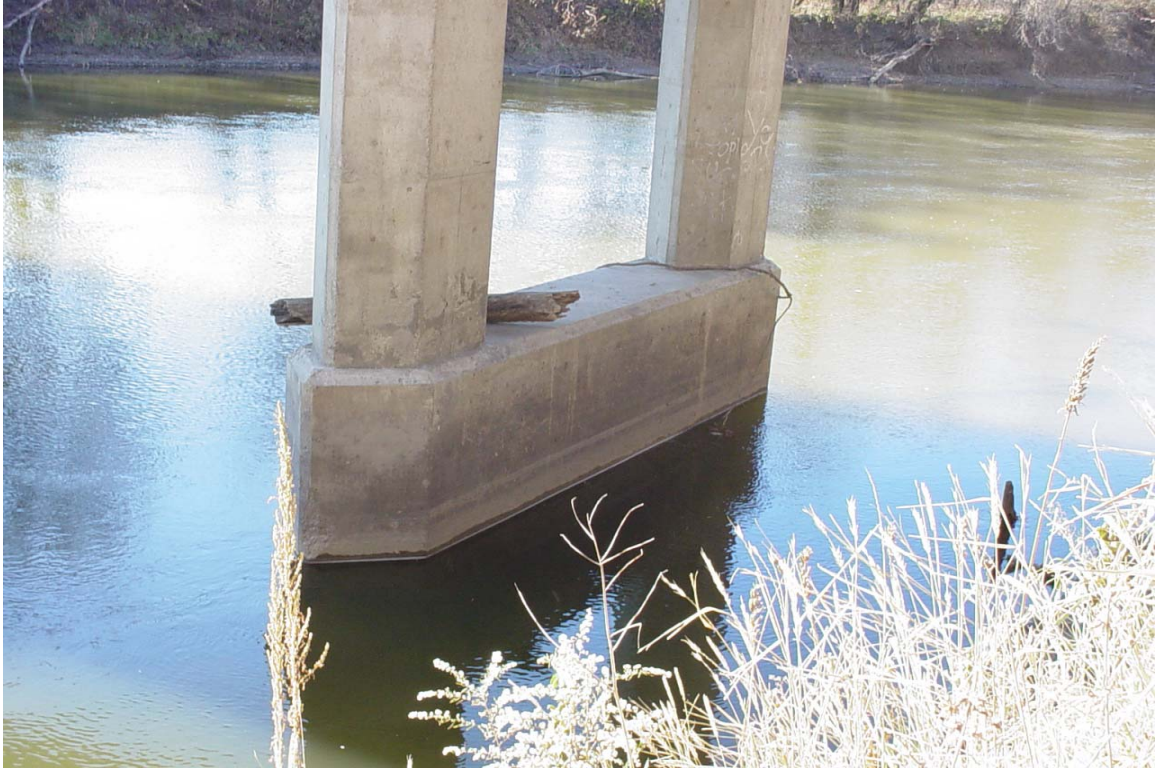
- (A) The top of the footing was exposed from the upstream nose to the upstream quarter point along the south face of Pier 1 with 3 inches of vertical face exposure detected.

- (B) The footing was exposed along the mid portion of the north face of Pier 2 with 2 inches of vertical face exposure detected.
- (C) Scour depressions, 2 foot in radius and 1.5 foot deep (Pier 1) and 5 foot in radius and 1.5 foot deep (Pier 2), were observed at the upstream noses of both piers.

- (D) An area of section loss, 1.5 feet wide by 6 inches high with a penetration of 1/8 inch, was observed 1.5 feet below the waterline on the south face of the upstream end of Pier 1, and an area of section loss, 10 inches wide by 1.5 feet high with a penetration of 1 inch, was observed at the waterline on the downstream nose of Pier 1.

- (E) A light accumulation of 6-inch-diameter timber debris was scattered on the channel bottom around Pier 1, and a moderate accumulation of timber debris, up to 1 foot in diameter, was observed at the upstream end of Pier 2 and extending along the north face.

Photograph 1. View of Pier 1, Looking Southwest.

- (A) Monitor the timber debris at both piers, and if found to be increasing in the future, removal operations may become warranted to prevent any adverse affects on the bridge.
- (B) Monitor erosion of north embankment and review need to reestablish the erosion control measures necessary to protect the embankment at the North Abutment.
- (C) Reinspect the submerged substructure units at the normal maximum recommended (NBIS) interval of five (5) years.

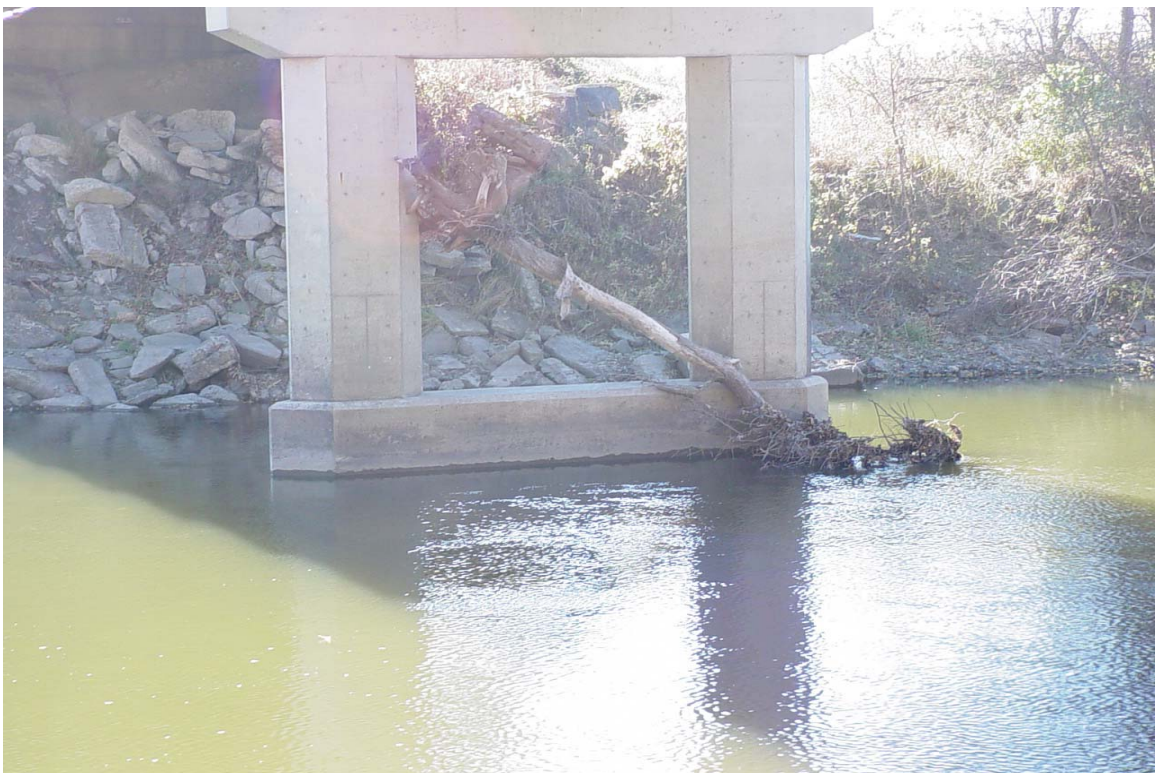
Photograph 2. View of Pier 2, Looking Southwest.

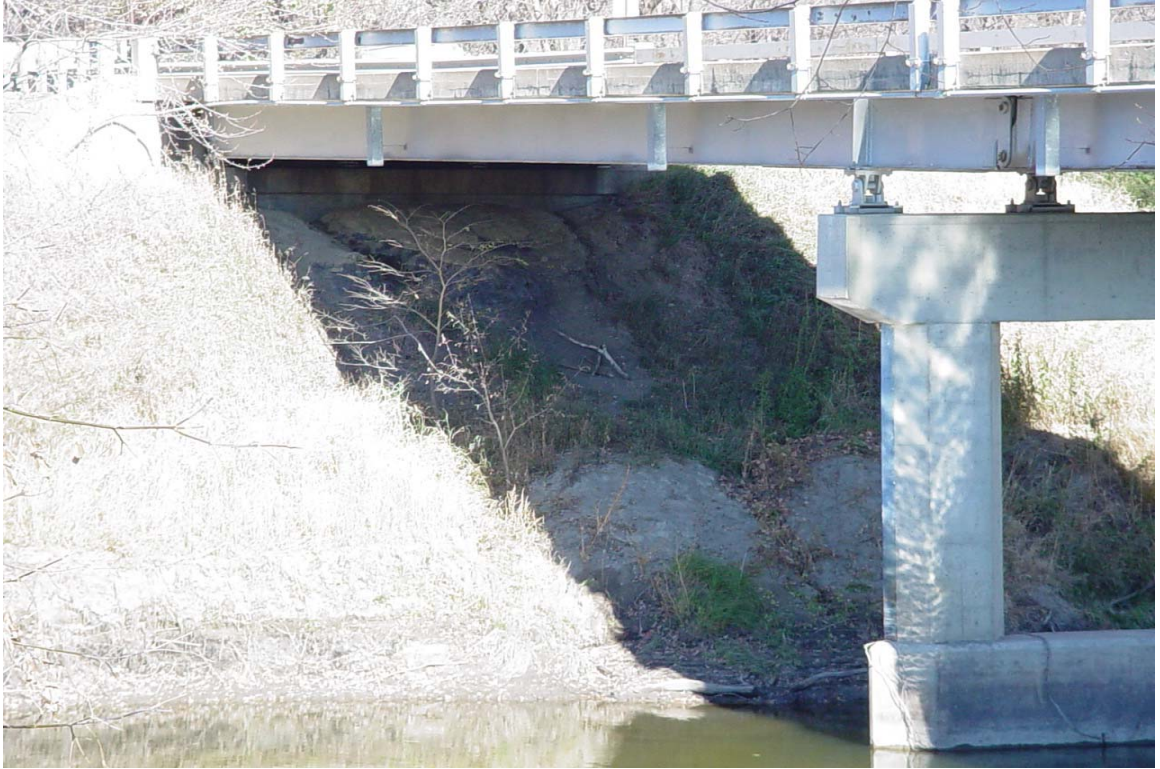
- (F) The north embankment exhibited heavy erosion due to poor slope protection.

Photograph 3. View of North Embankment, Looking Northeast.

Monitor erosion of north embankment and review need to reestablish the erosion control measures necessary to protect the embankment at the North Abutment.
